Orchard irrigation performance: Permanent under-tree sprinklers

*Dan Bloomer, Page Bloomer Associates,
and Andrew Curtis, Hawke's Bay Regional Council*

This month we are presenting results from another evaluation of orchard irrigation that uses bigger sprinklers, each covering a number of trees. This was a permanent under-tree system with sprinklers every third tree in every second row. Our jargon term for these is "spraylines".

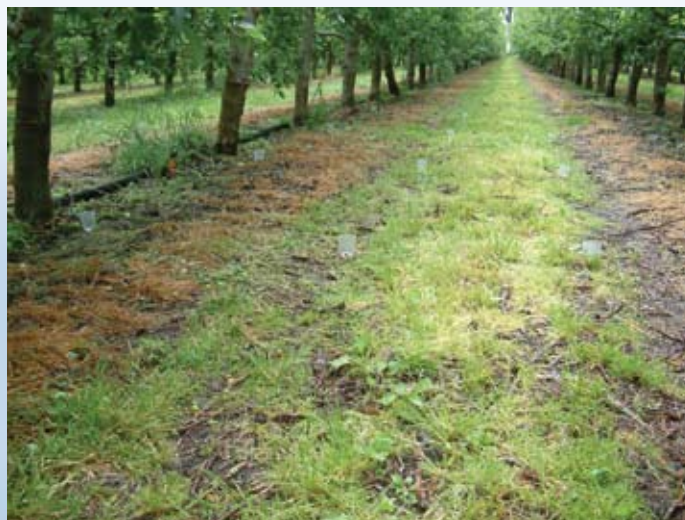
To assess this system we set up a grid of 48 collectors between six adjacent sprinklers and ran the irrigation for two hours.

View of orchard row with grid of collectors in place.

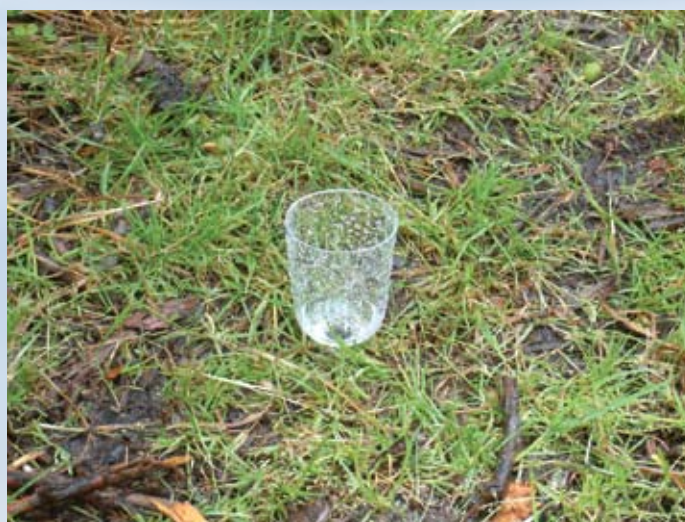
We had to use low collectors because the trajectory of water from the low sprinklers was only just about the ground. Their opening is 65mm in diameter, which is the smallest we consider usable.

View of collector used to measure irrigation uniformity.

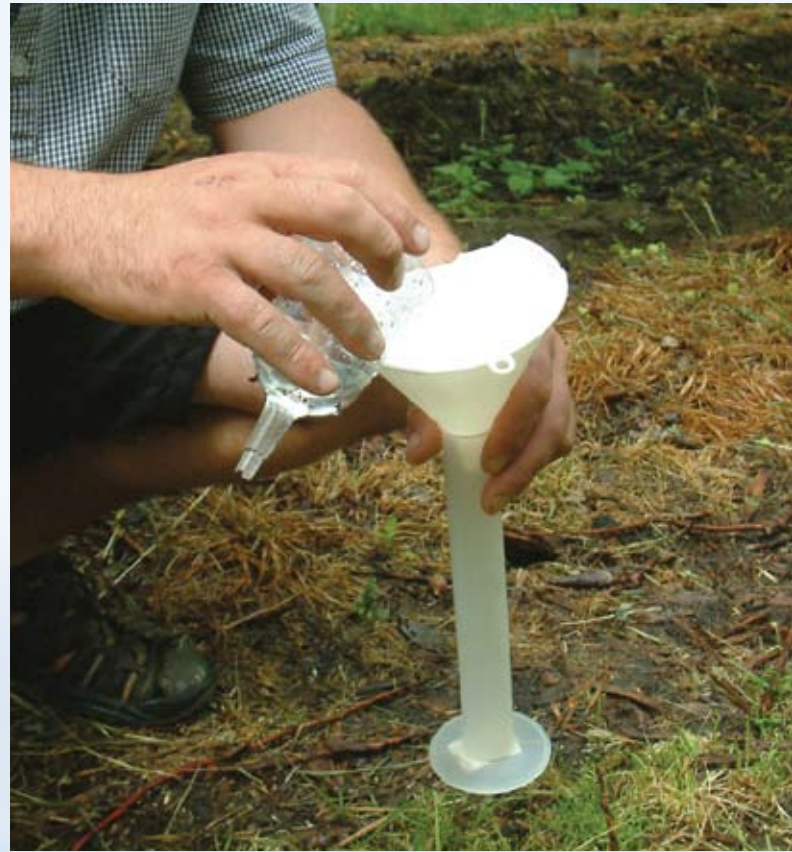
We measured the depth of water in the collectors and divided by the area of the collector opening to determine the depth of irrigation applied.

Measuring the volume of irrigation collected.
