Orchard irrigation performance – an under-tree travelling irrigator

*By Dan Bloomer, Page Bloomer Associates; and
Andrew Curtis, Hawke's Bay Regional Council*

Under-tree travelling irrigator

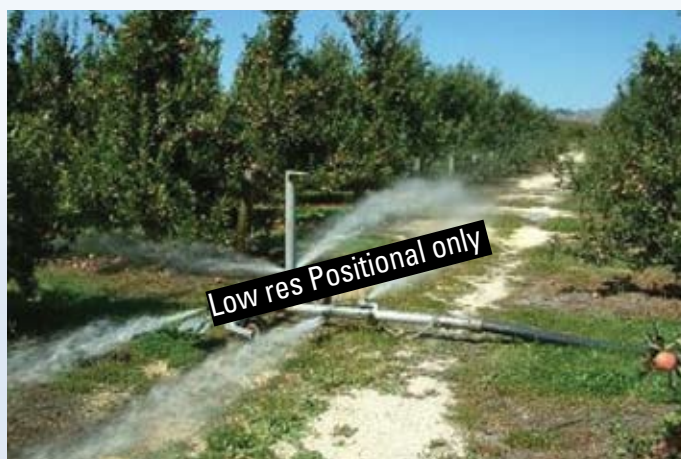
In the last of this series of irrigation system evaluations, we take a look at a travelling under tree irrigator. On this machine, the usual gun has been replaced by four ground-level nozzles jetting water sideways under the canopy. The design aims to water three rows either side of the nozzle carriage and hose.

Figure 1: Under-tree travelling irrigator.

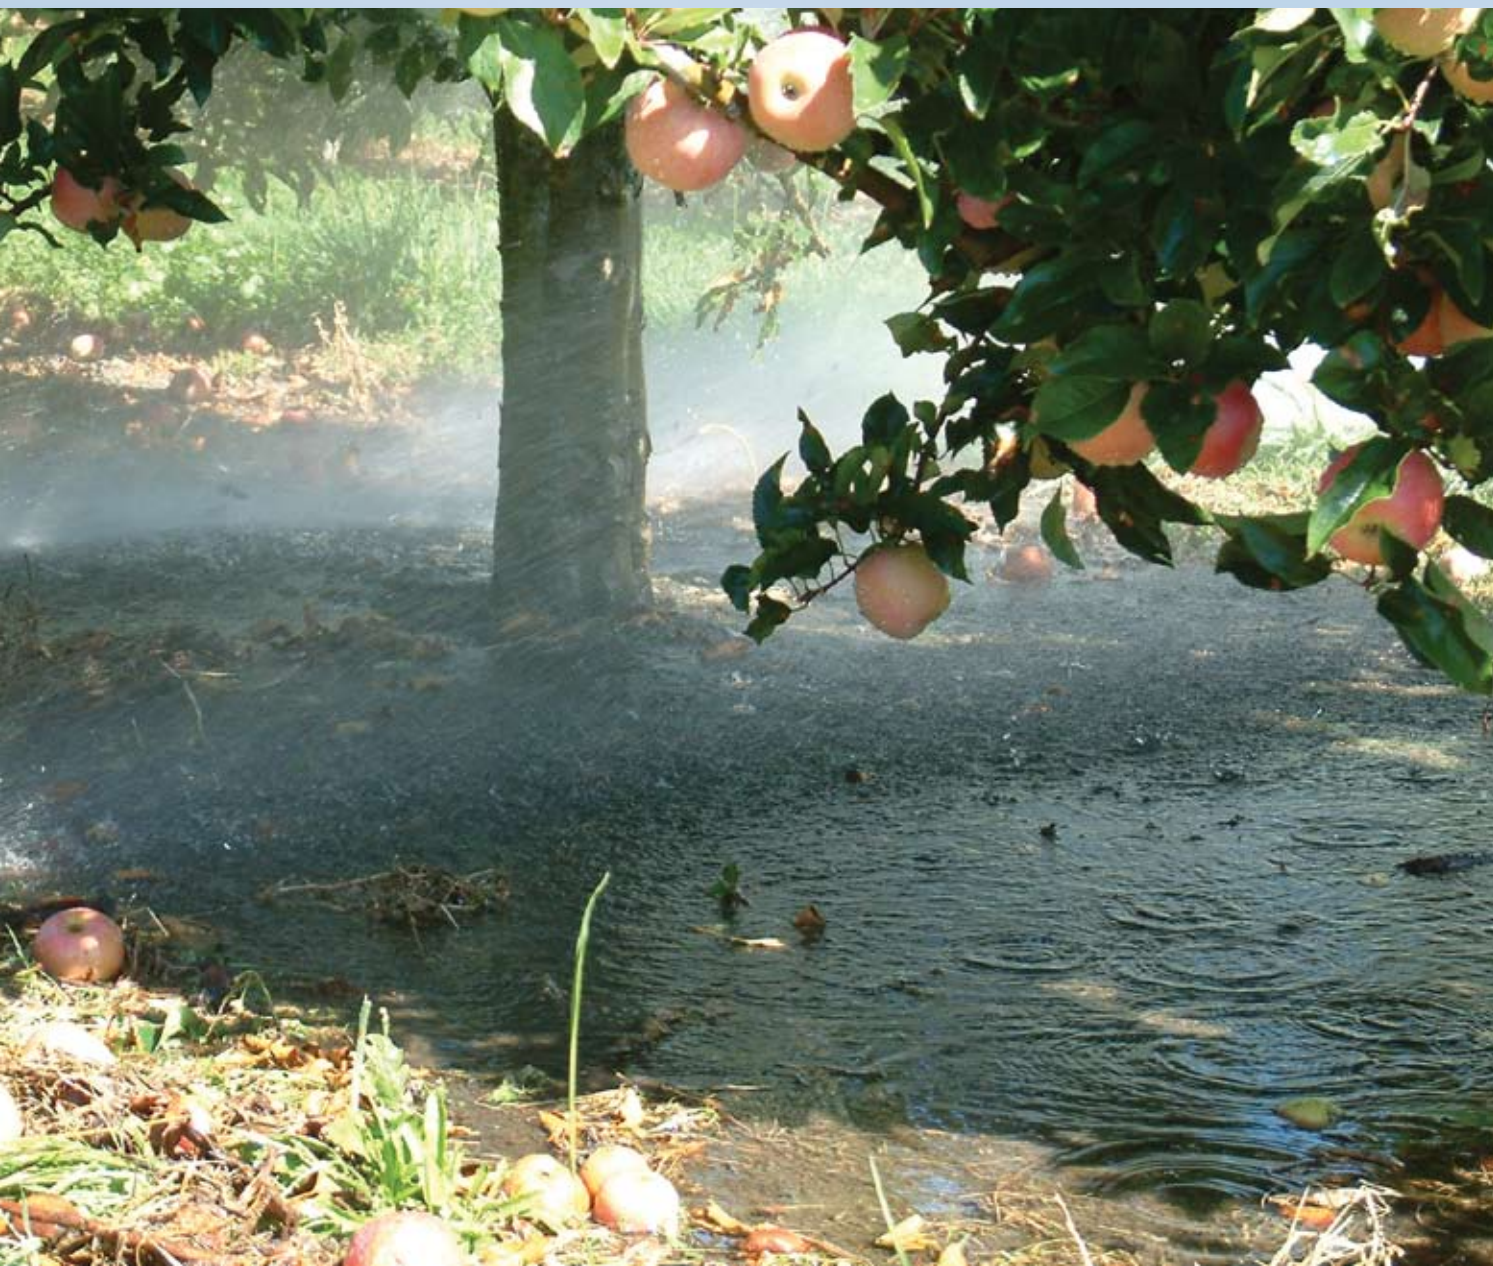
Figure 2: Irrigation ponding as a result of very high application rates.

The main things limiting performance were uneven application and extremely high irrigation application rates. Together these led to different trees receiving quite different amounts of water.

Also, because the system applies water much faster than it can soak in, there is a lot of redistribution. Pondered water runs to lower areas. It seems in this case that this may actually have helped get water out to the rows furthest away from the irrigator.

Apply less water more often

Our second test ran the irrigator at a faster speed, so less water was applied. We noticed this appeared to reduce the amount of free water flowing to lower areas.

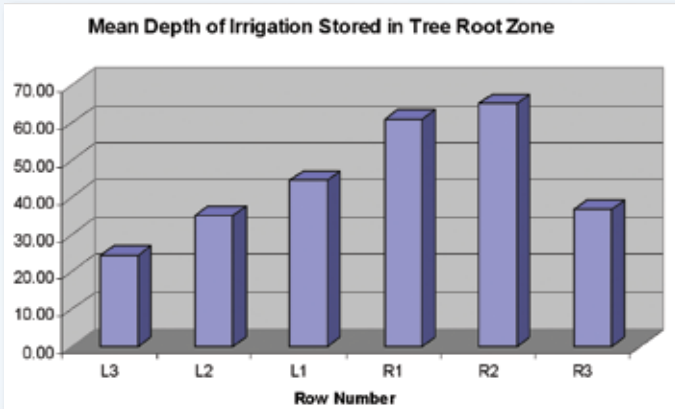
Figure 3: Graph showing the depth of water retained in the root depth of six trees.

The first test applied 35mm of irrigation on average across the block. But the amount we found stored in the root zone of individual trees 24 hours later was quite variable as shown in Figure 3.

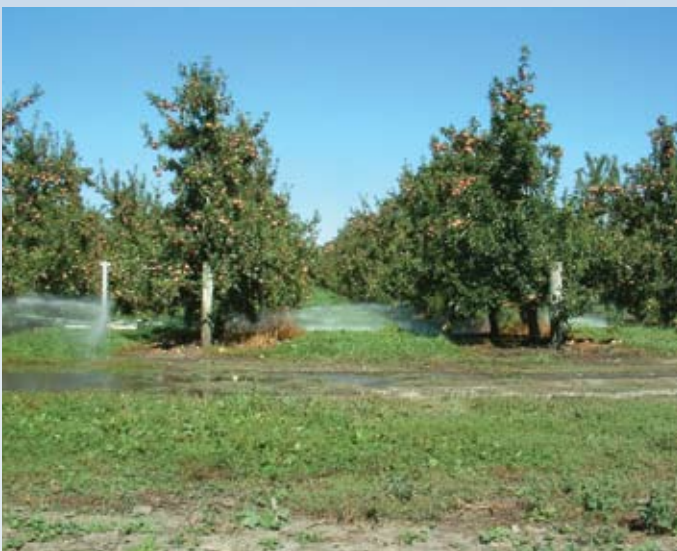
Three transects across the line of travel were set up. Each transect had 24 collectors, arranged at 1m intervals away from the hose line. The trajectory of the jets was very low and the force very high. We used a big soil corer to extract cores, and set

Figure 4: Distribution from under tree travelling irrigator.

After the irrigator had passed each transect, the volume of water collected was measured and the depth of water applied calculated as shown in Figure 7. The set-up did not get the water to the edge of the irrigation strip so the outer rows received a little less water. With the nozzle set up, the inside rows also appear to miss out – the jets shot straight past them. **continued>**

Increase the sprinkler pressure and therefore throw.

Increasing the pressure will immediately increase the distance wetted and get more water out to the furthest trees.

An alternative would be to decrease the set spacings (shift spacing) to improve the overlap. In this case, watering five rows at a time would give a better overlap.

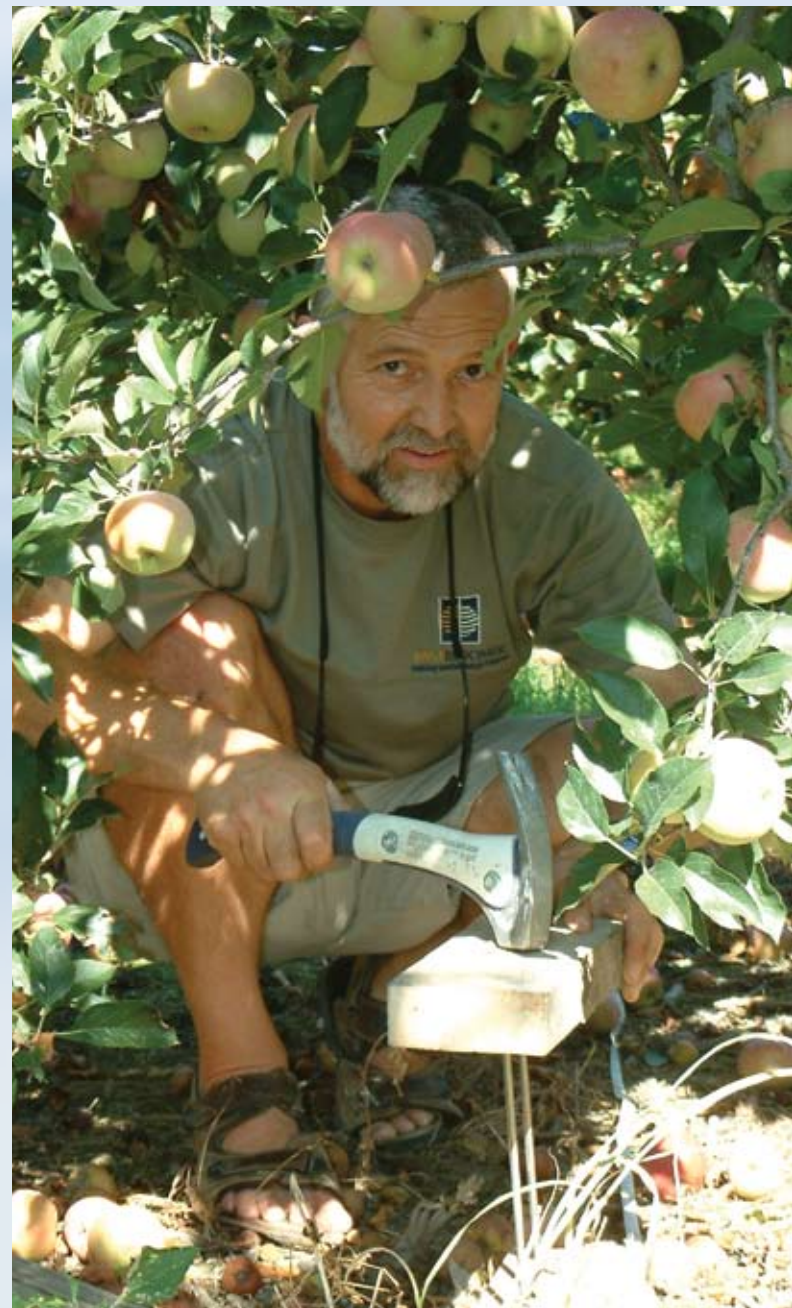
Figures 5: Dan Bloomer installing the TDR rods to measure soil moisture content.

We also set out 72 sets of TDR rods to measure the change in soil moisture. Our rods were 60cm long, so they correspond to the rooting depth of the trees.

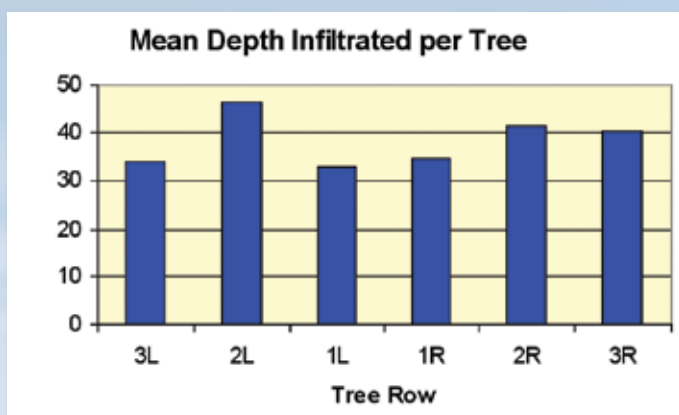
Figure 7: Average depth of water infiltrated in each row.

The two graphs show different patterns. The soil storage appears more even than the applied depths would suggest. There are several possible explanations.

Doing our maths on the results, we find the Distribution Uniformity is about 0.65. This is a poor result, and implies that one and a half times the target depth has to be applied if most of the trees are going to get enough water. Some will be very wet by then. 🌿
